**Exponent Report on PG&E Caribou-  
Palermo Asset Condition Investigation**

**November 1, 2019**

## **PG&E Caribou-Palermo Asset Condition Investigation**

Exponent  
149 Commonwealth Drive  
Menlo Park, CA 94025

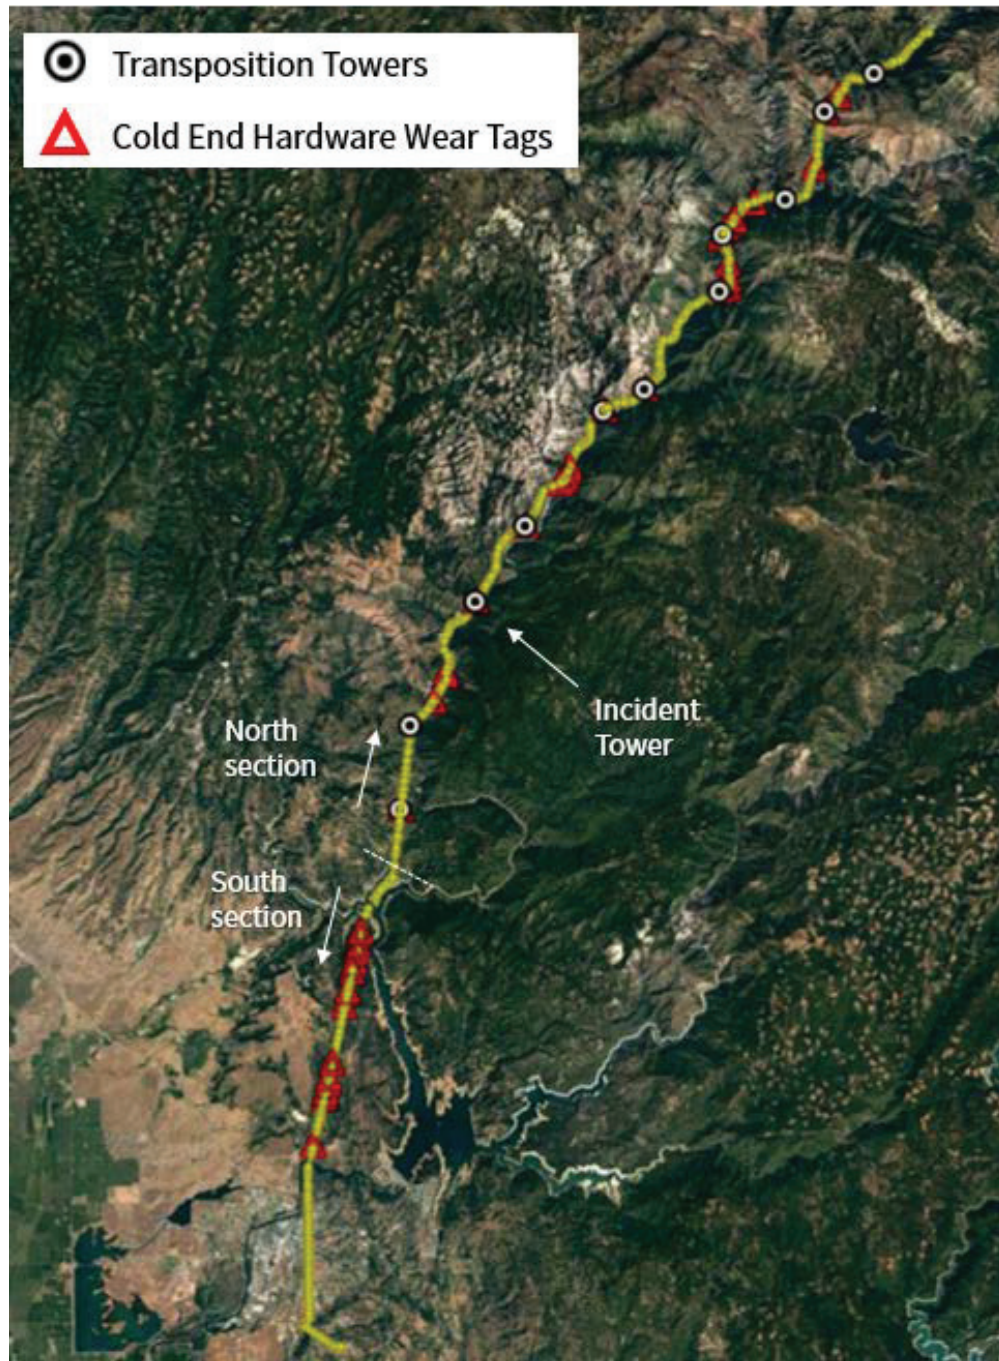
were given high-priority cold-end hardware / wear tags following the Camp Fire. Transposition towers and cold-end hardware / wear tags are mapped in Figure 27. These seven wear tags represent 39 percent of the cold-end hardware / wear tags on Caribou-Palermo North. Each of these Caribou-Palermo North transposition towers contains a steel bar that bridges two jumper insulators, shown in Figure 28. This specific assembly appears to be unique to Caribou-Palermo North and PTM, and its role in long-term cold-end hardware wear is unknown at this time. The southern portion of PTM contained two transposition towers with similar construction to the incident transposition tower :027/222. One of these two PTM towers had a “B” priority cold-end hardware related wear tag. Neighboring BCRC and CRO transposition towers have a similar bridging bar on transposition towers. However, the bar does not appear to pass through the shoe as in the Caribou-Palermo North transposition towers.

Figure 27. Map of Caribou-Palermo showing the north-south dividing line, cold-end hardware / wear tags, and transposition towers.

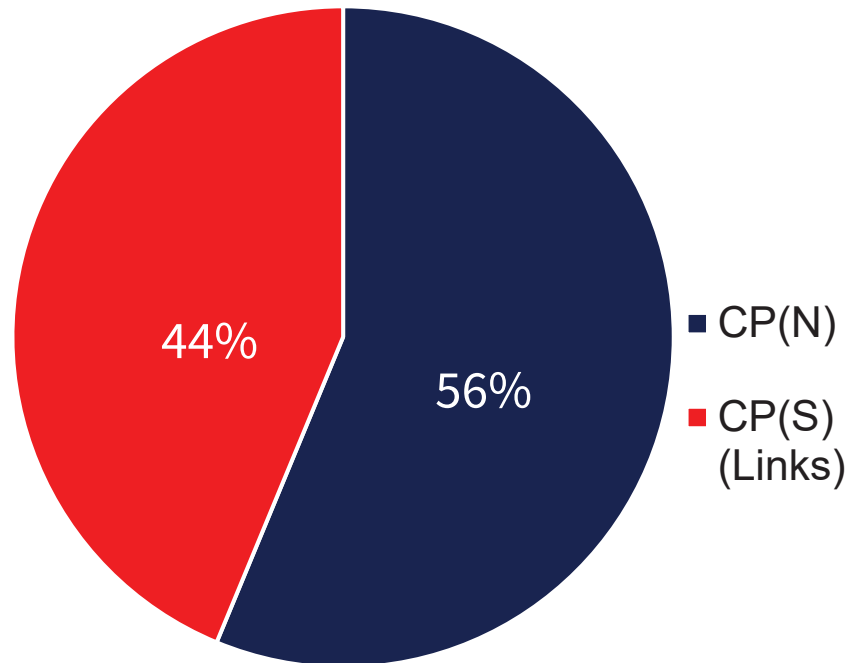
There were 32 high-priority cold-end hardware / wear tags on Caribou-Palermo from November 8, 2018, to June 19, 2019. These tags were approximately split 60 percent / 40 percent between the northern and southern portions of Caribou-Palermo, shown in Figure 29. All of the 14 high-priority cold-end hardware / wear tags on Caribou-Palermo South were on structures with link connections. Of the 18 high-priority cold-end hardware / wear tags on Caribou-Palermo North, 11 (61 percent) were on dead-end towers with insulated jumpers, depicted in Figure 30. The remainder were on standard suspension towers. Seven of these 11 dead-end towers were transposition towers with the bar shown in Figure 28.

Figure 29. Breakdown of cold-end hardware / wears tags on the entire Caribou-Palermo line.

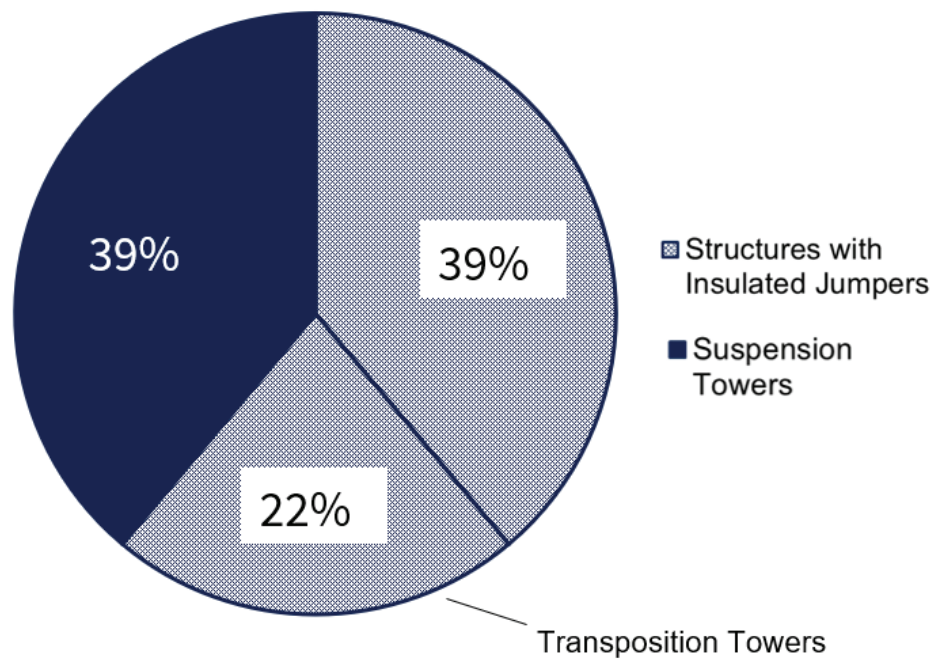
Figure 30. Breakdown of cold-end hardware / wear tags on Caribou-Palermo North.

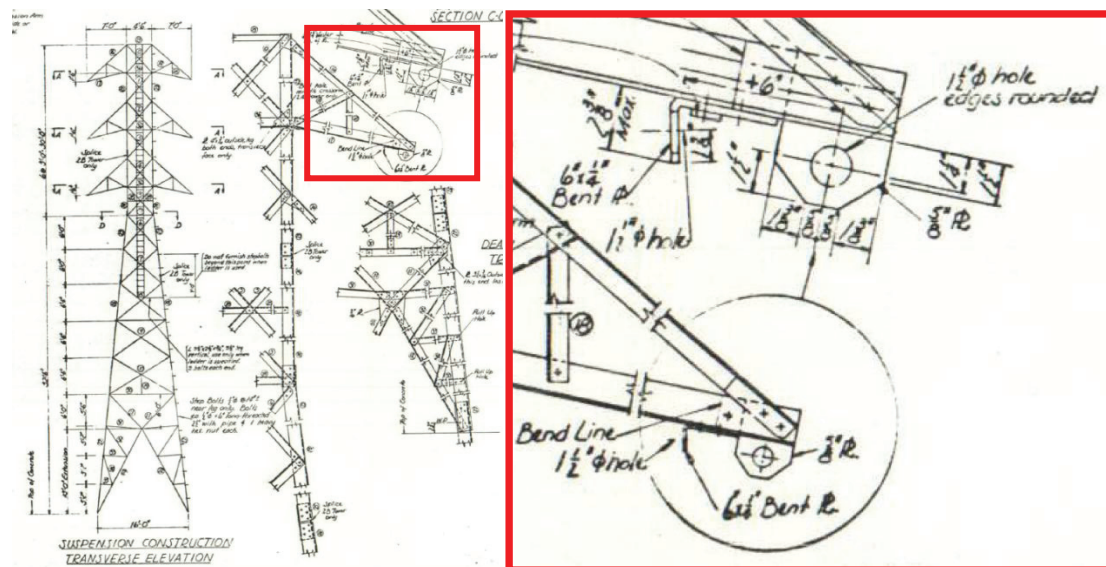
Figure 31. Drawing of “Suspension Construction Transverse Elevation” Types 2A and 2B towers from Drum–Rio Oso 115 kV design book dated October 20, 1930. The hanger plates used in these towers are 5/8 inch thick and have a 1 1/2-inch-diameter eye.

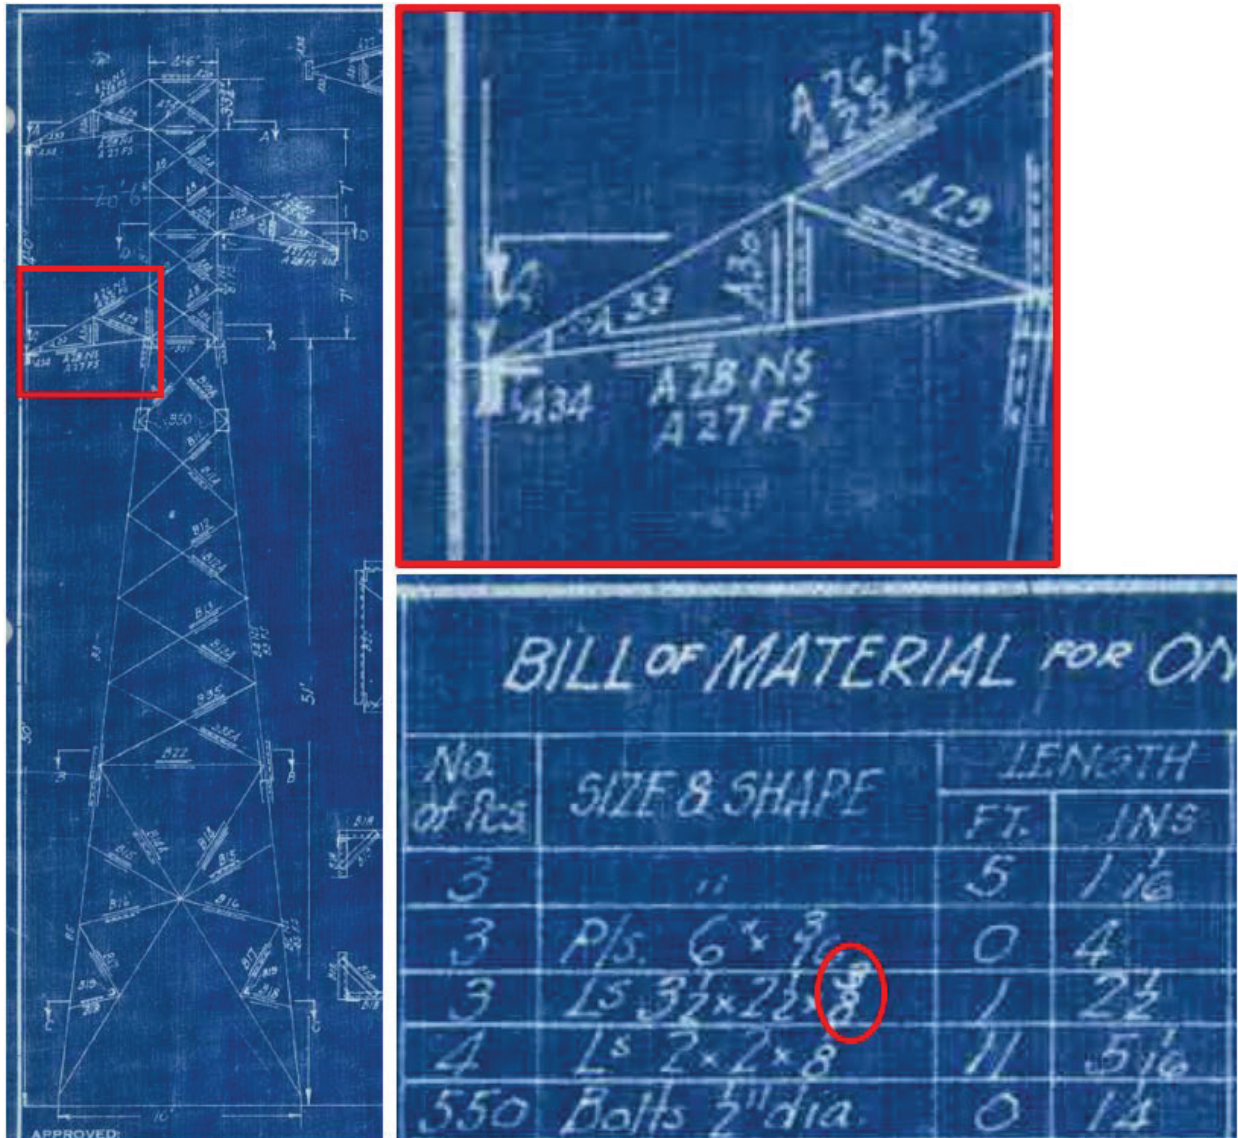
Figure 33. Drawing of "Valley Suspension "B" Tower" dated June 14, 1920. This is a valley dead-end tower originally installed on the 165 kV Caribou–Golden Gate Line. The hanger plates used in these towers are 3/8 inch thick.

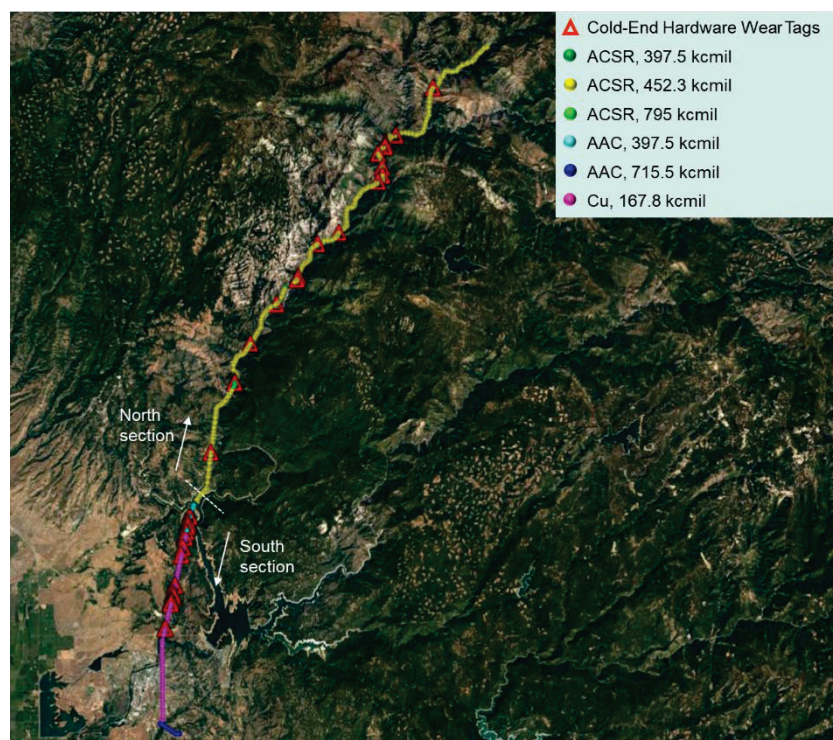
To determine whether conductor type correlates with wear tags, the locations of Caribou-Palermo cold-end hardware / wear tags were overlaid on a map of Caribou-Palermo conductor types, shown in Figure 35. A high concentration of cold-end hardware / wear tags was found on Caribou-Palermo South, where a copper conductor is used. These tags were associated with link connections, as described in a previous section. Cold-end hardware / wear tags were also found throughout the length of Caribou-Palermo, including in segments composed of 452.3 kcmil ACSR, 795 kcmil ACSR, and 397.5 kcmil AAC.

Figure 35. Map of Caribou-Palermo cold-end hardware / wear tags and conductor types.

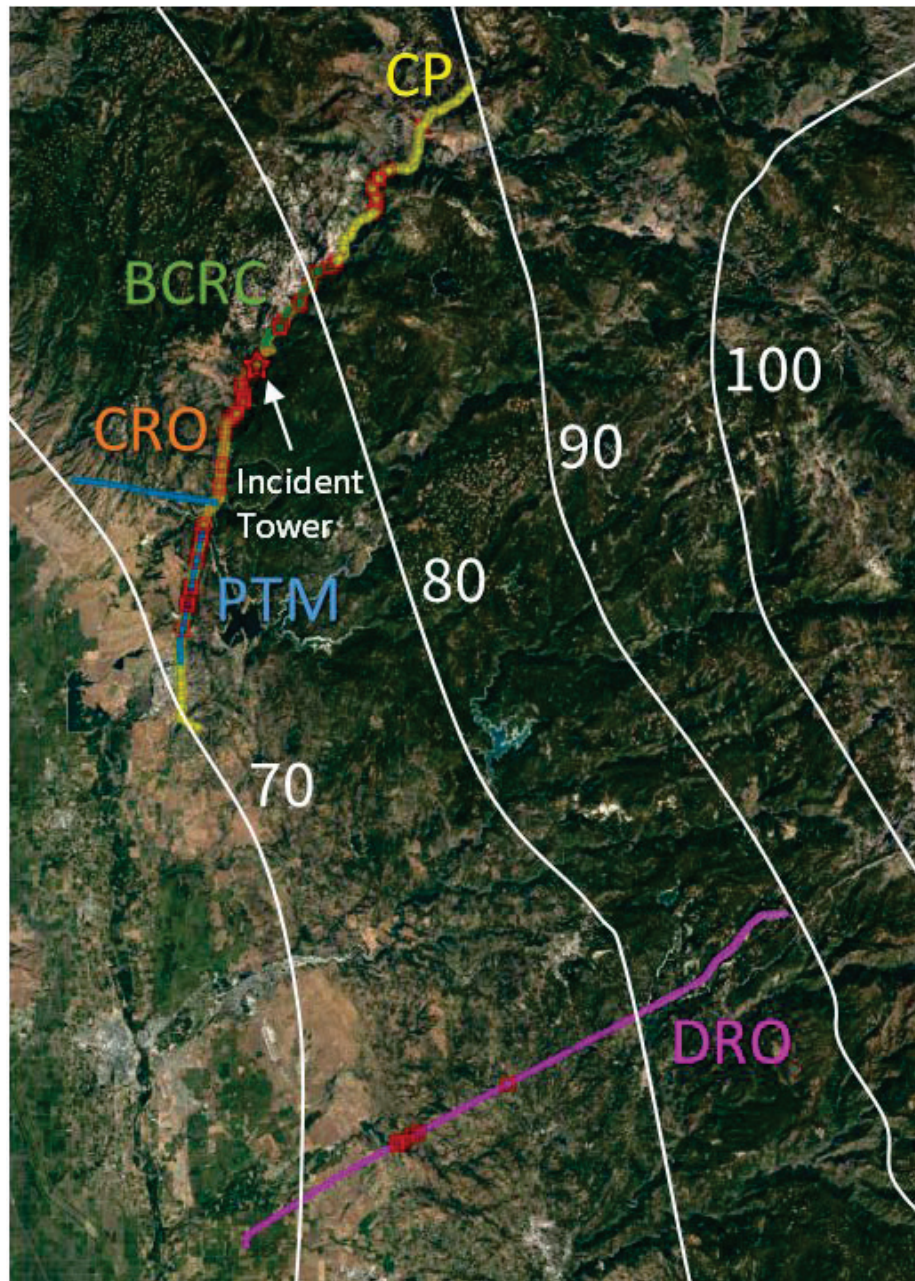
Figure 36. Contour map of peak wind speed (50-year return period) in the area of Caribou-Palermo and the comparison lines, with “A” and “B” cold-end hardware / wear tags highlighted. No obvious correlation between peak wind speed and damage locations is observed. Speeds are reported as the maximum one-minute interval at 33 feet above ground level.

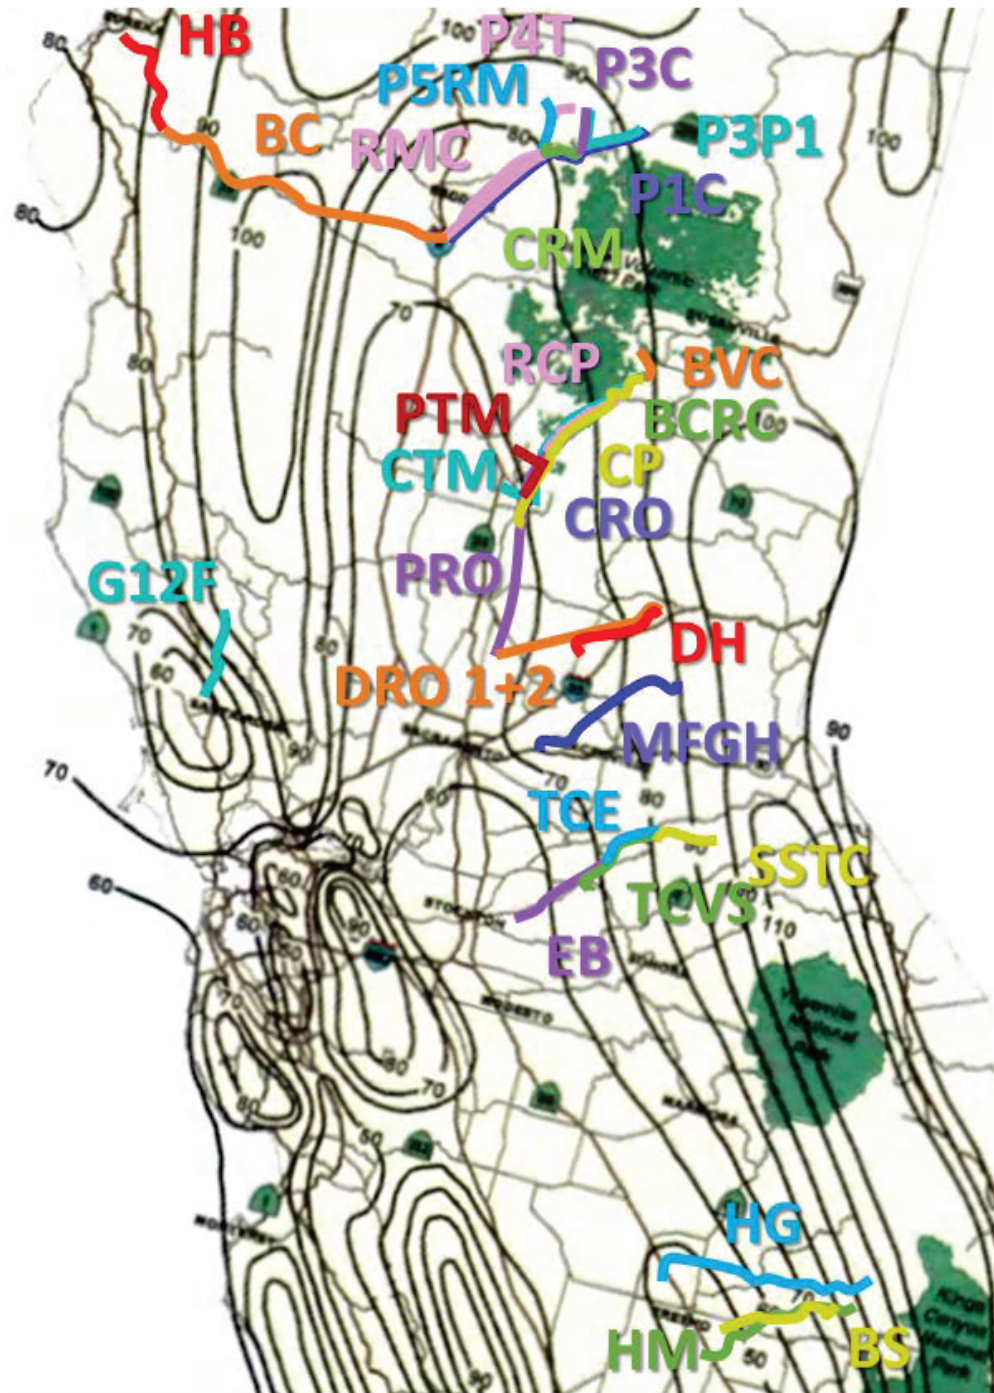
Figure 37. Contour map of peak wind speeds across Caribou-Palermo and comparison lines. No obvious correlation between peak wind speeds and lines with higher tag rates is observed. Speeds are reported as the maximum one-minute interval at 33 feet above ground level, over a 50-year return period.

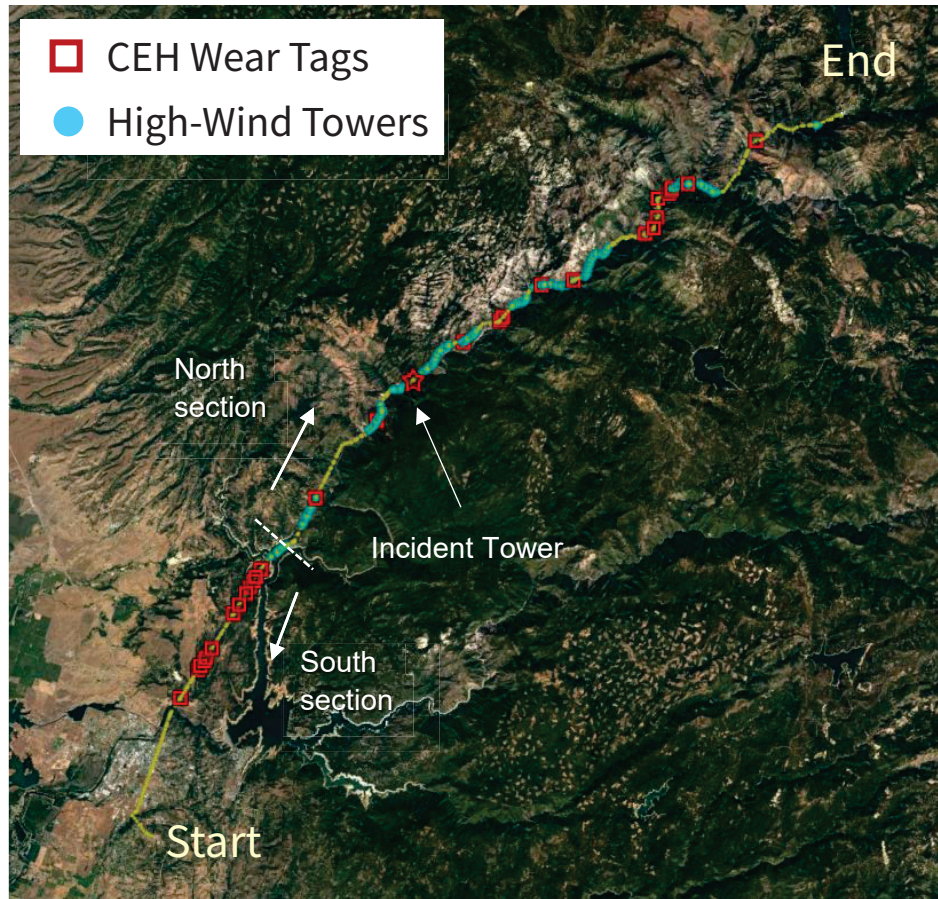
We then examined each individual tower to determine whether it spends an elevated amount of time under high wind conditions. About 10 percent of towers experience 605 hours or more of wind greater than 22 mph per year, so this was set as the cutoff (Figure 40). If wind were a major contributing factor, it would follow that a large number of high-wind towers would correlate to an increased damage tag rate. Fifteen of the 28 lines examined show nearly no high-wind towers (4 percent or less), and only four exceeded 21 percent: Caribou-Palermo North, Humboldt-Bridgeville (HB), Pit #4 Tap (P4T), and Rock Creek–Poe (RCP), Figure 41. Nearly half of the towers in Caribou-Palermo North are high-wind towers, the highest rate of any line examined. A map of high-wind towers overlaid with high-priority cold-end hardware / wear tags is shown in Figure 42. Many of the Caribou-Palermo North towers that exhibit high-priority cold-end hardware / wear tags are exposed to elevated wind conditions.

Figure 42. Map of all towers in the Caribou-Palermo line, with high-wind towers and cold-end hardware (CEH) wear tags overlaid.

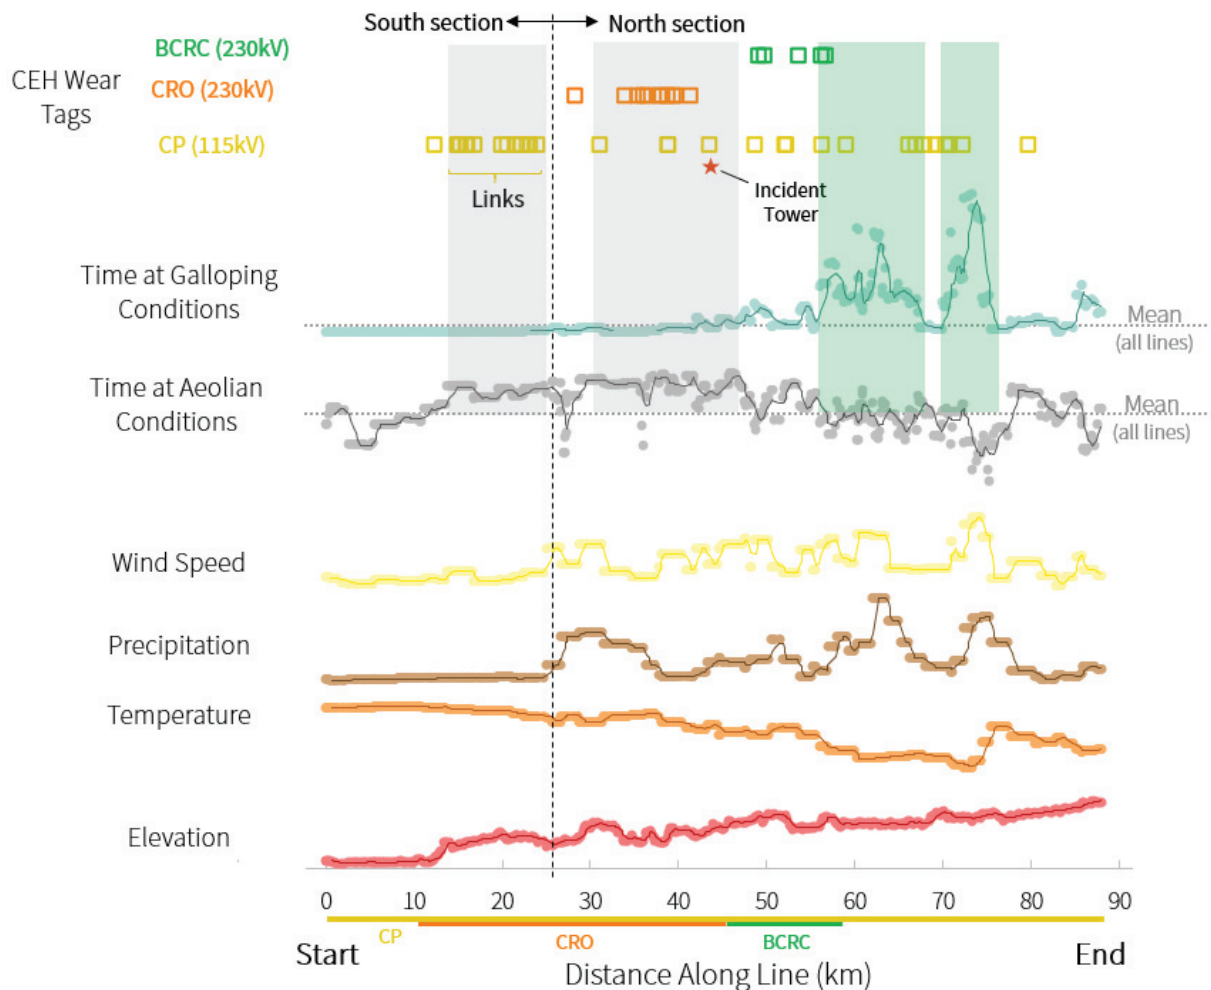
Many of the Caribou-Palermo wear damage tags are located within areas of elevated Aeolian time (highlighted in gray), and areas of elevated galloping time (highlighted in green), Figure 45. On the southern section of Caribou-Palermo, a high density of cold-end hardware wear tags are located in a region that has both elevated Aeolian time and towers that make use of link connections. Although some cold-end hardware / wear tags are co-located with high-wind towers (as highlighted in Figure 45), a large number of high-wind towers with no cold-end hardware / wear tags are observed. Further, wear tags are also present in areas of reduced wind speed, Aeolian, and galloping conditions. Thus, while wind is likely required to cause cold-end hardware wear, and the Caribou-Palermo line has the most aggressive wind conditions analyzed, no direct correlation between peak (50-year return) wind, Aeolian, or galloping conditions and high-priority wear tags can be made at this time.

Elevation, span weight (described in greater detail below), temperature, and precipitation also exhibit no obvious correlation to the presence of cold-end hardware wear or other wear-related tags, as shown in Figure 45. In addition to elevation, further analysis was also carried out on the terrain slope surrounding each tower, as peaks in elevation may correlate to elevated localized winds. Factors that make such environmental contributions difficult to characterize include effects of local terrain, as well as differences in maintenance, age, and design of structures and equipment.

Figure 45. Factors vs. distance along line for the Caribou-Palermo line. All time-dependent data shown are averages of the full-year data from 2010. Areas of elevated Aeolian time (highlighted in gray), and areas of elevated galloping time (highlighted in green). CEH stands for cold-end hardware.

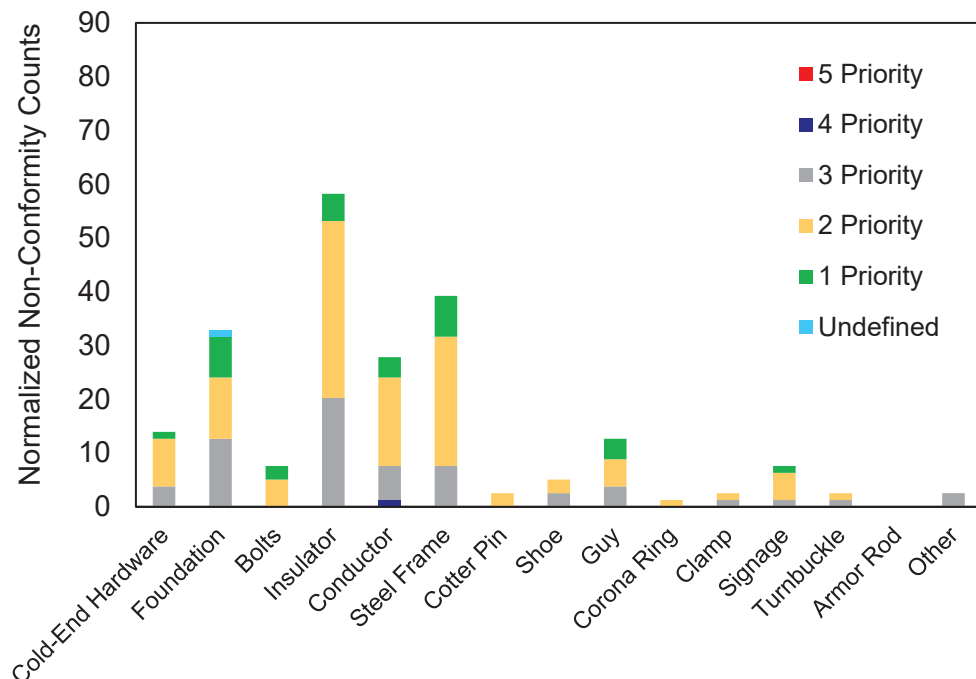
The inspector-noted nonconformities during the post–Camp Fire climbing inspections were obtained from the Pronto forms associated with the same 79 structures. The inspector comments and nonconformity priority ratings from these forms were binned into components, as shown in Figure 54. These priority ratings were on a numerical scale, as follows, and were used as an estimate of damage level:

Figure 54. Binned post-Camp Fire inspector-noted nonconformities from the same 79 structures as Figure 53, obtained from Pronto forms.

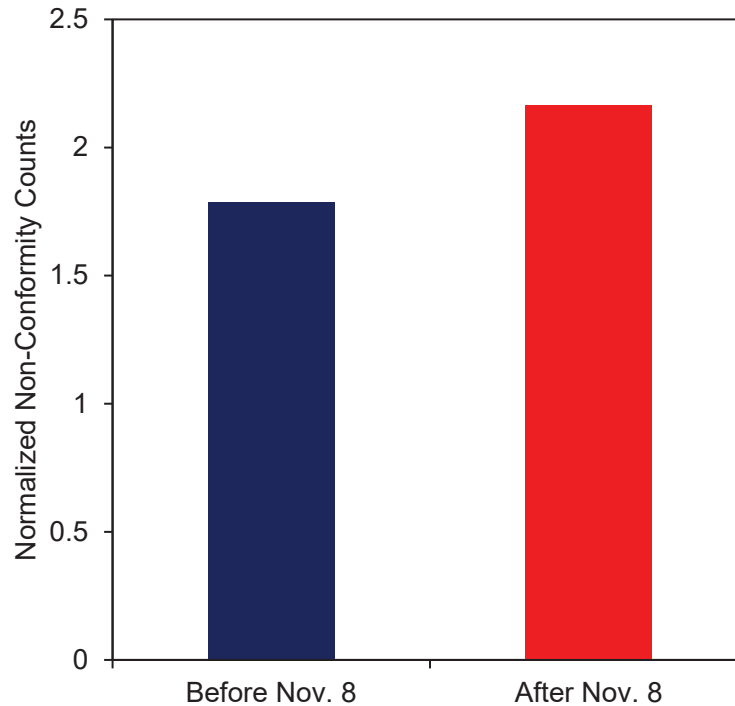
Comparison between pre– and post–Camp fire inspections on the 79 Caribou-Palermo towers showed that a similar number of issues were noted, shown in Figure 55. However, the types and severity of issues differed. The majority of issues identified pre–Camp Fire were related to sealed foundations, missing signs, or loose or missing bolts. The issues identified post–Camp Fire included substantially more insulator and conductor-related damage, including those relating to both cold and hot-end hardware, Figure 54. The newly implemented enhanced inspection procedures, including the CIRT or DIRT review, appear to have led to substantial improvements in identifying progressive or wear-related damage near the tops of towers, particularly associated with cold- and hot-end hardware.

Figure 55. Comparison of the number of inspector-noted nonconformities from pre- and post-Camp Fire climbing inspections.

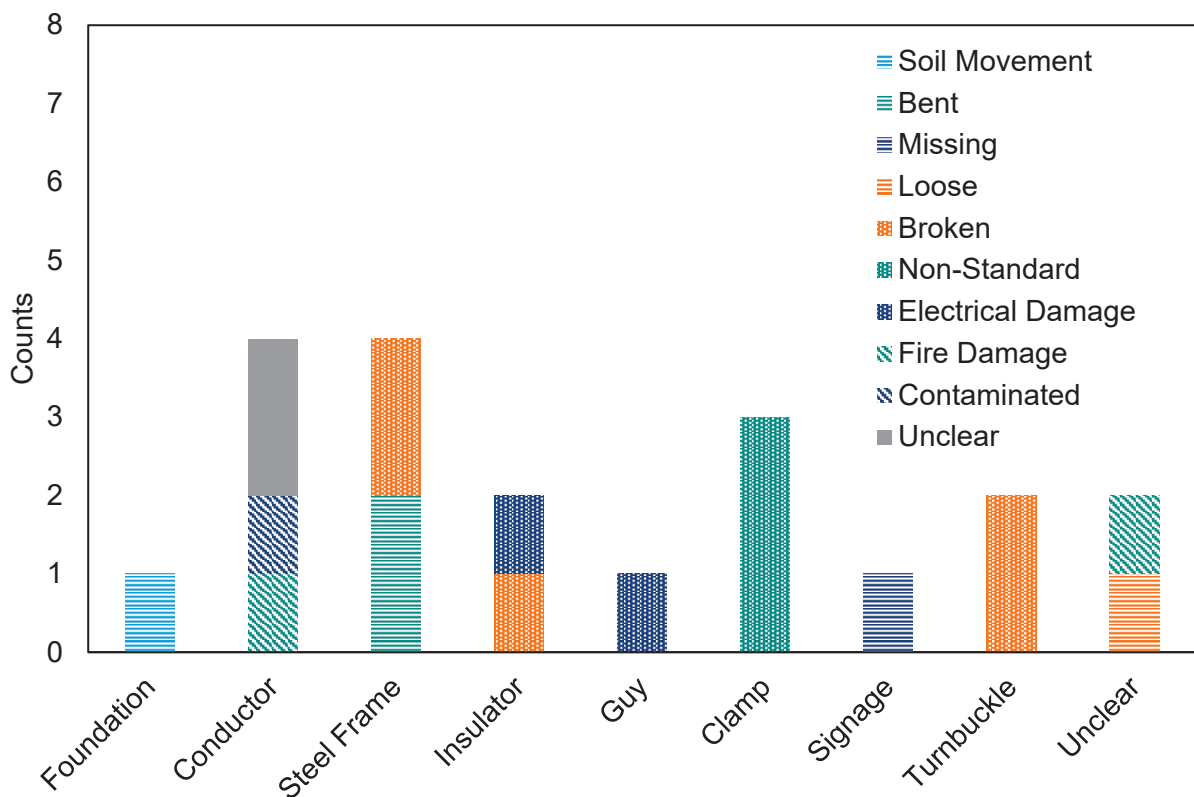
Historical high-priority (converted to “A” and “B”) Caribou Palermo tags were binned by component type and damage mode using the same approach as described in the “Post-Camp Fire Caribou-Palermo Tag Analysis” section. In Figure 58, a breakdown of the component types and damage modes shows that steel frame and conductor related issues accounted for the highest number of historical tags. No high-priority tags associated with cold-end hardware wear were found. A review of historical tags for comparison lines also found no high-priority cold-end hardware / wear tags during the period from January 2001 through October 2018.

Figure 58. High-priority tag counts broken down by component type and damage mode for Caribou-Palermo over the period from January 2001 through October 2018.
